**MARINER'S  
UPDATE**  
COMPLIANCE WITH SIMPLICITY

# ENTRY GUIDE CHINA

# 20 YEARS PSC OBSERVATIONS

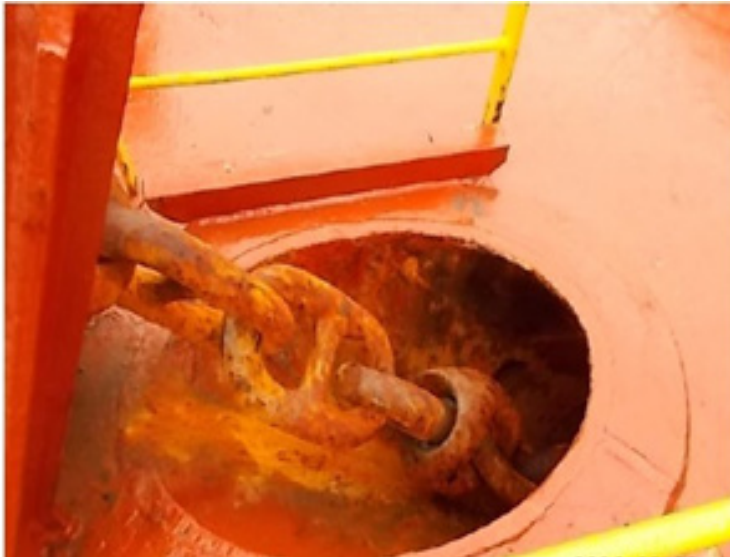
## Anchor chain swivel worn out- port side

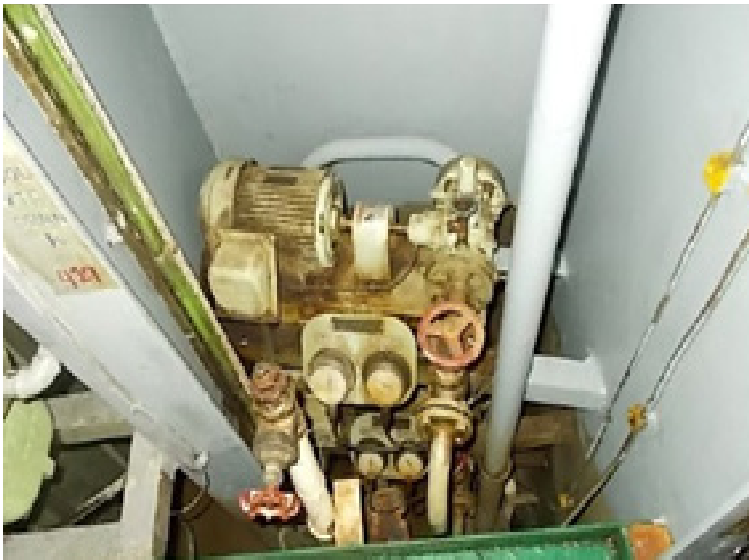
## Stern tube tank gauge glass unable to read

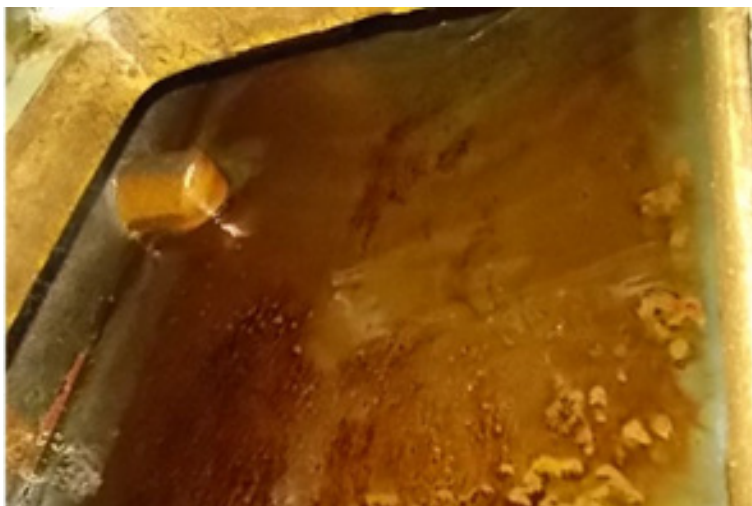
## Sign of oil sheen in auxiliary engine fresh water expansion tank

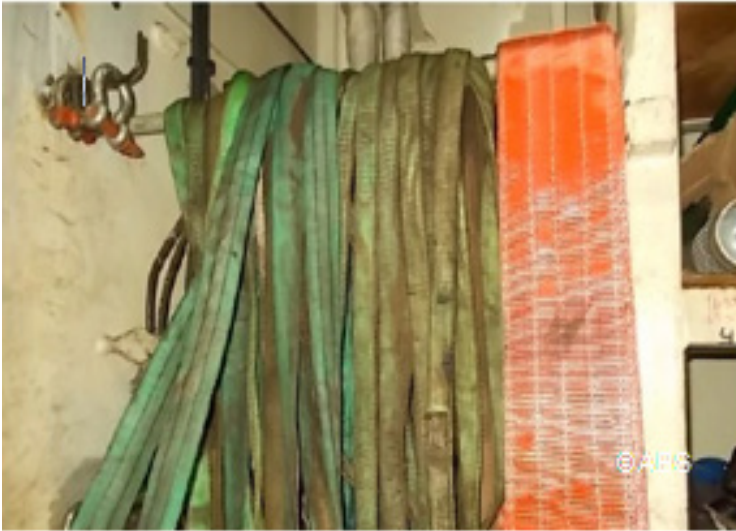
## Safe operating marking missing for slings

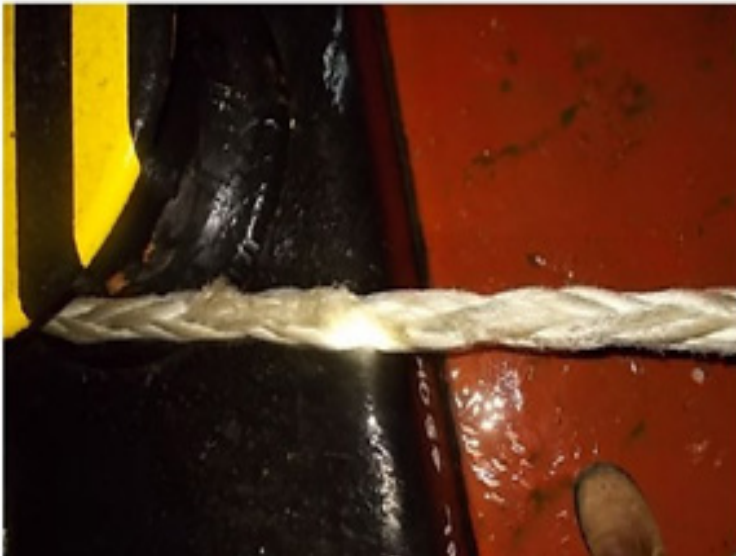
## Frayed mooring lines

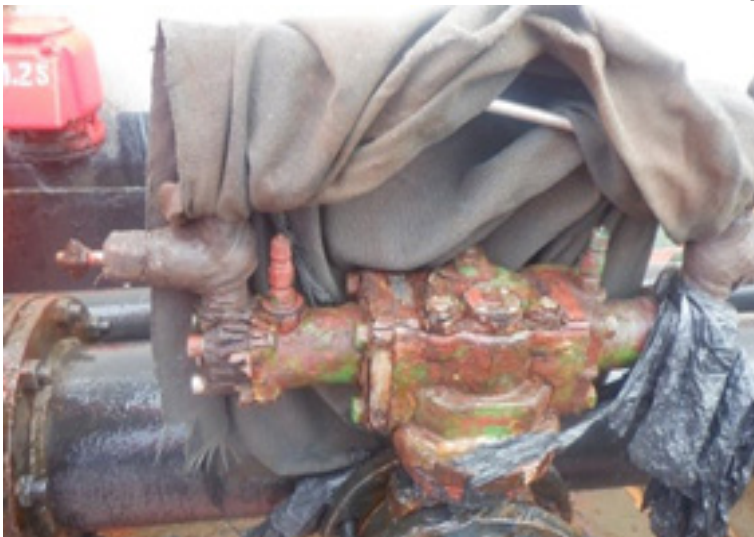
## Hydraulic actuating mechanism for bunker line valve wheel wasted and broke while operating

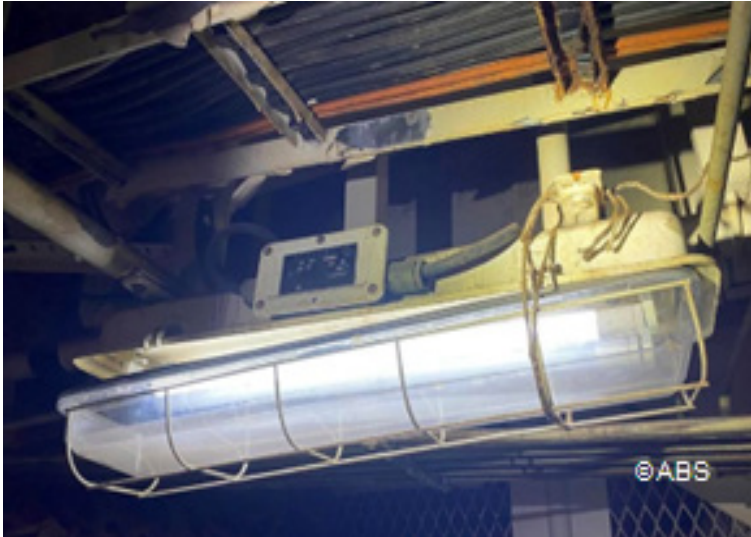
## Electrical fixtures are not secured properly

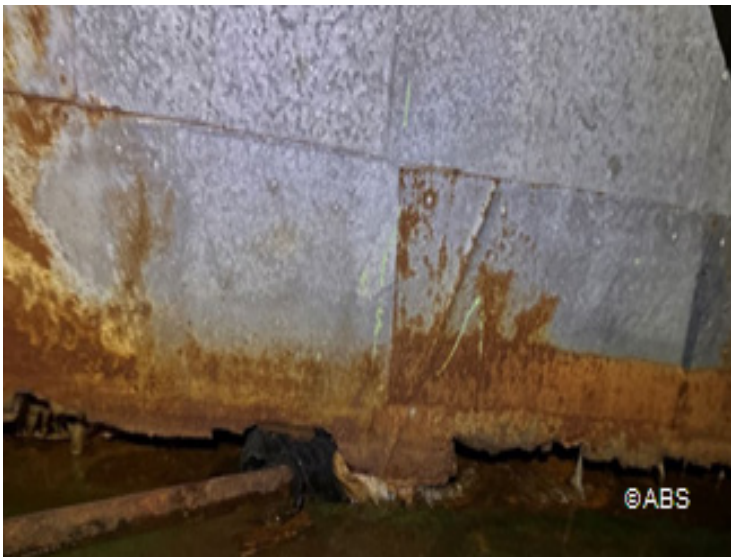
## Air conditioning and heating system encloser wasted

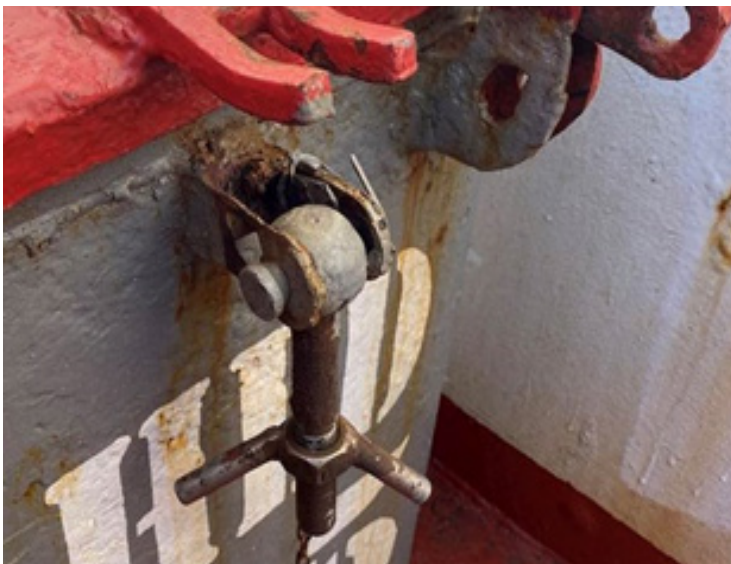
## Hatch cover securing hinge support wasted

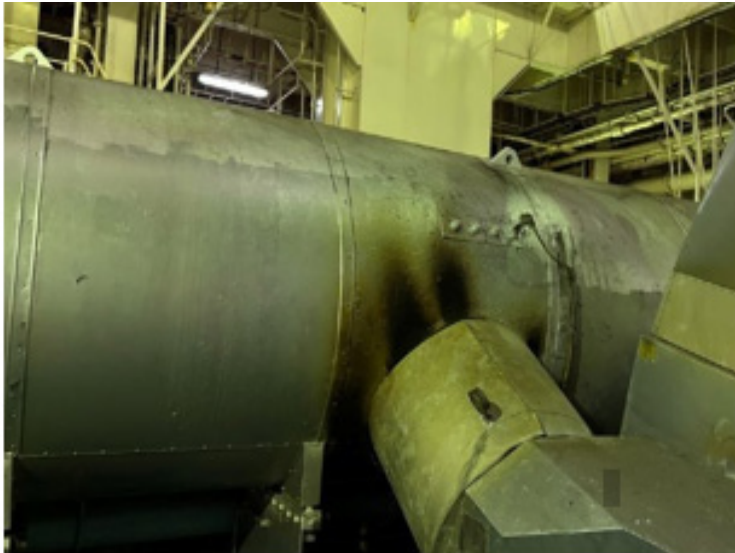
## Sign of exhaust gas leak at main engine exhaust gas trunk

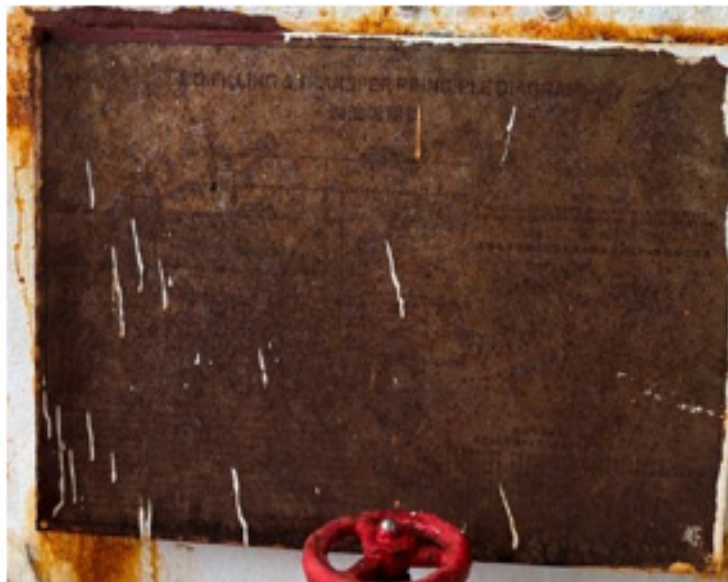
## Bunker procedure not legible

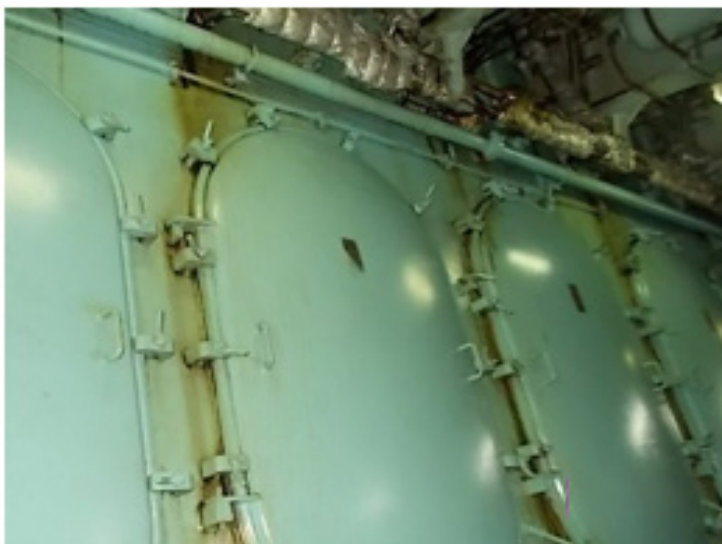
## Sign of fuel oil leakage

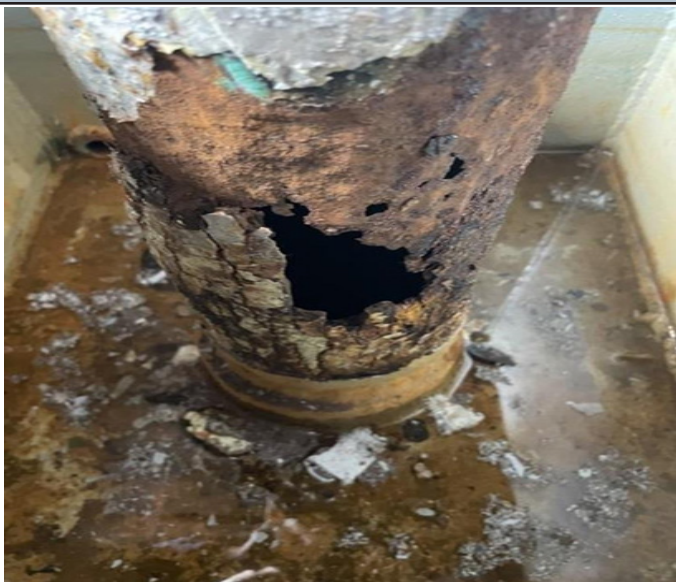
## Ventilators, air pipes, casings: Air pipe of no. 3 HFO tank

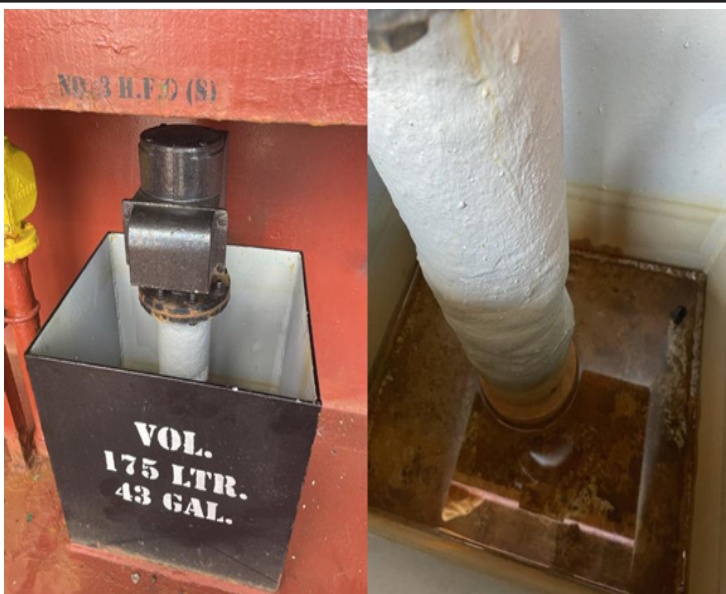
## Vent pipe repaired with canvas bandage

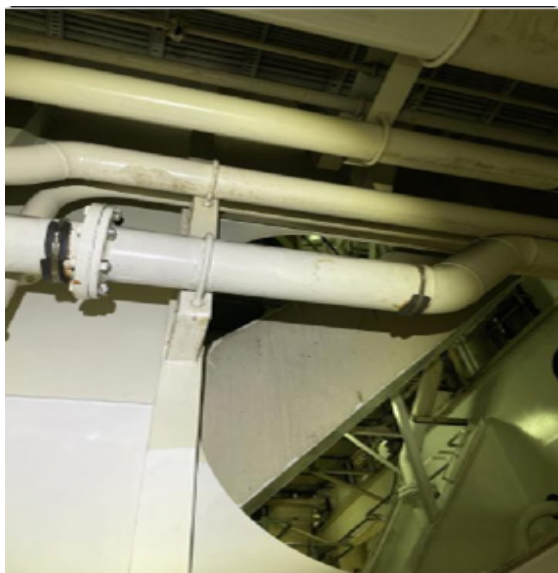
## Grey water overboard repaired with the rubber bandage

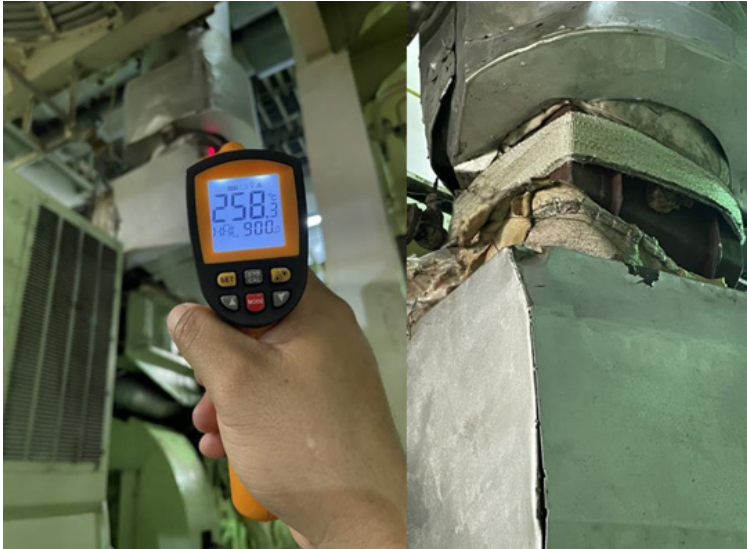
## Section of insulation missing on the turbocharger exhaust pipe 4 generators

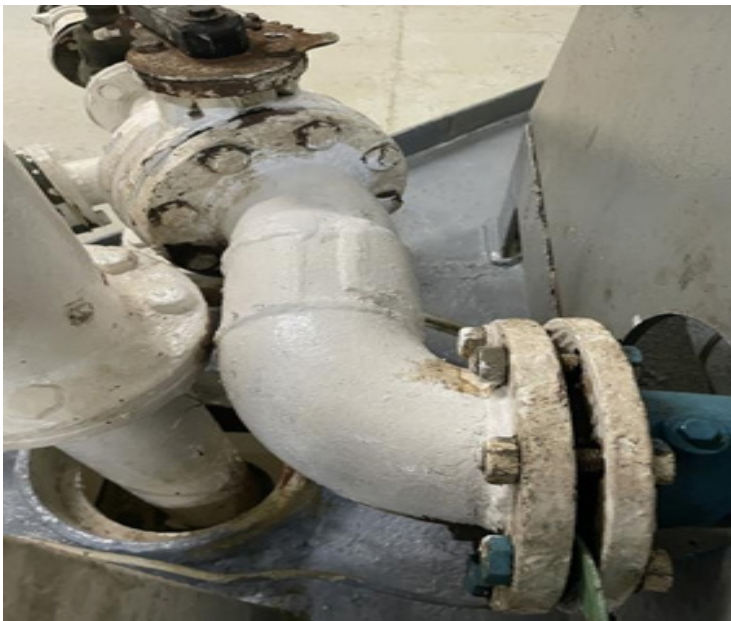
## Fresh water generator outlet pipe temporarily repaired with doubler

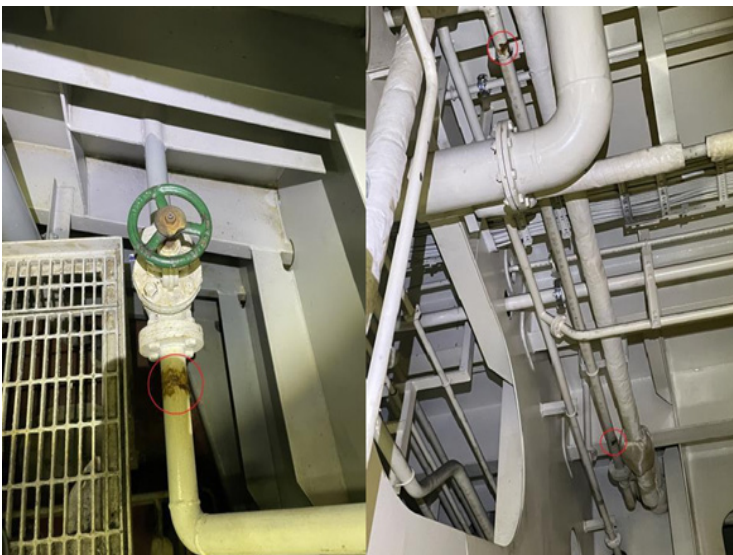
## Cooling seawater outlet for deck machinery found leaking in 3 locations

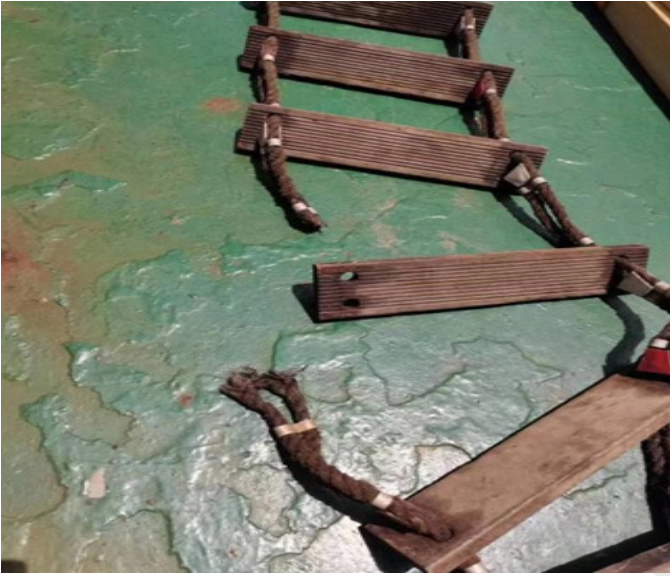
## Pilot ladders and hoist/pilot transfer arrangements

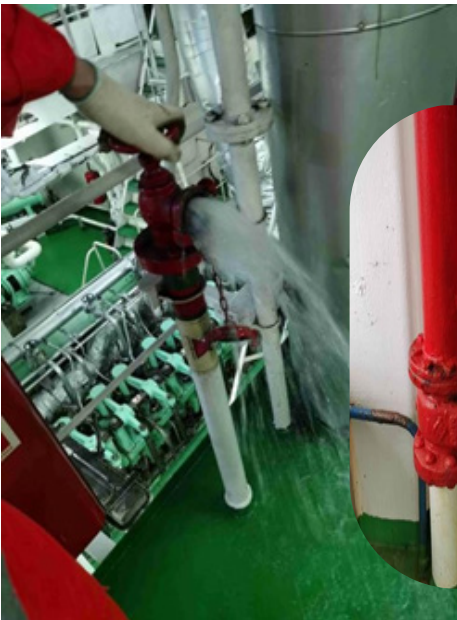
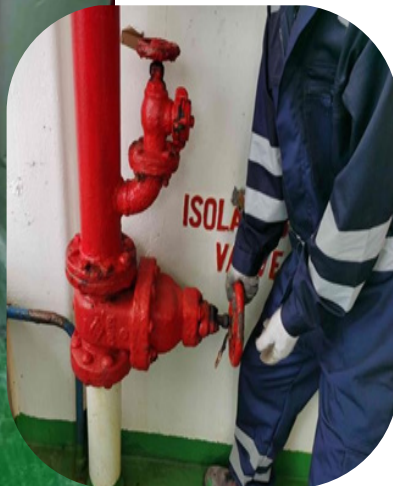
Isolation valve on fire main cannot be closed during testing the emergency

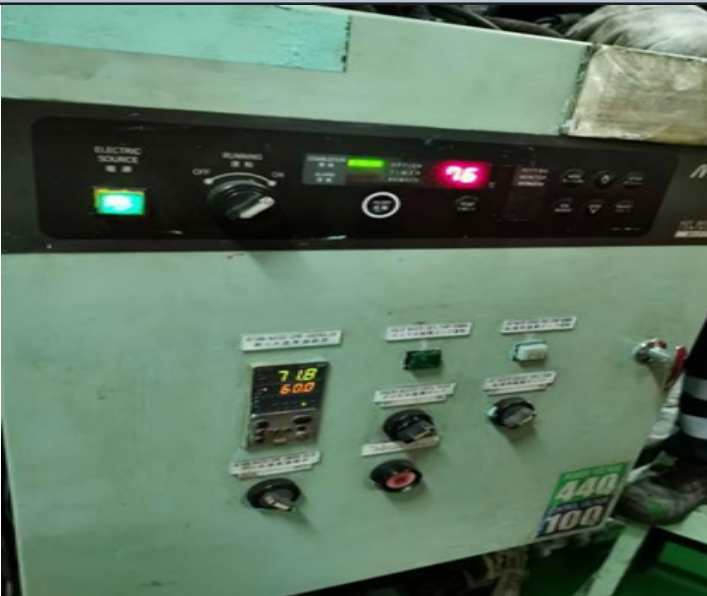
The flame failure alarm - hot water boiler did not activate during the test

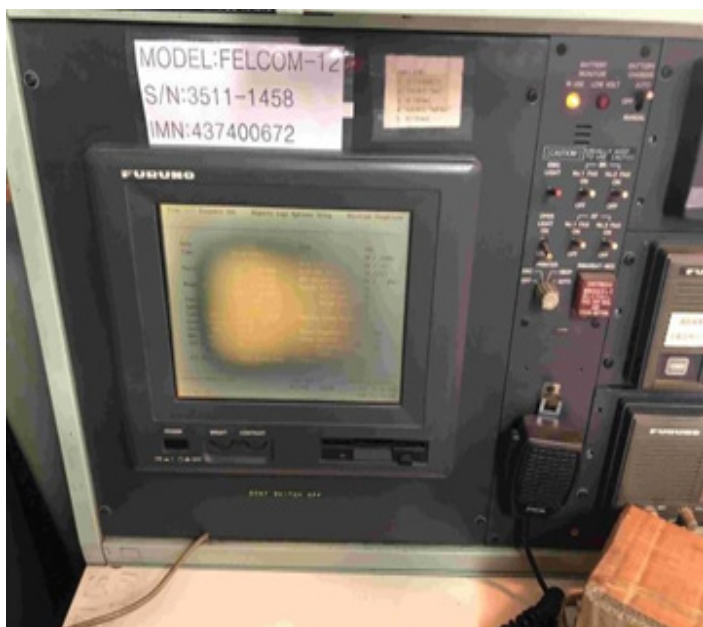
**The viewing screen of port side INMARSAT-C station is not clear**

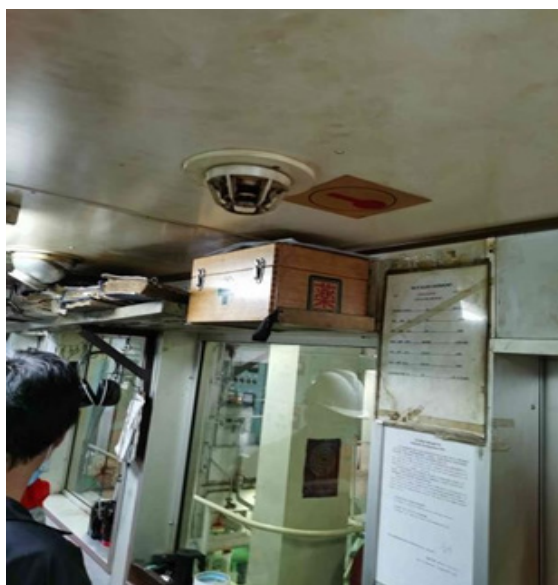
**There was no fire detector test tools onboard,**

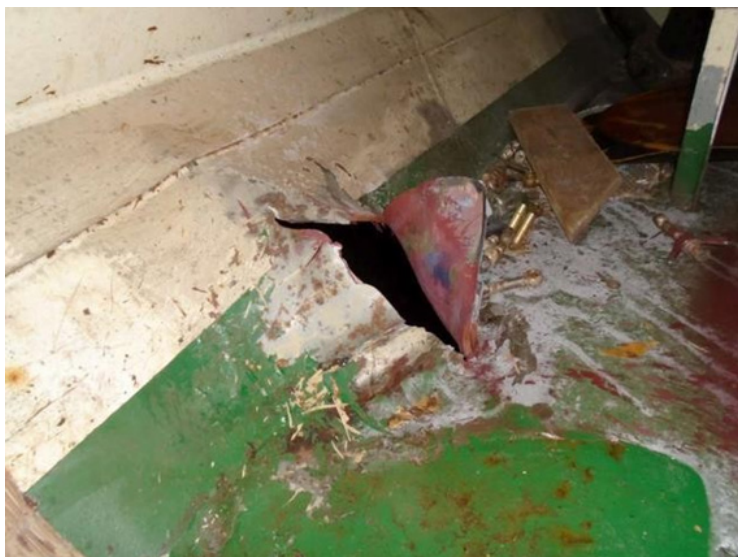
**bulbous bow broken with the hole approx. dimensions 4.5m horizontal and**

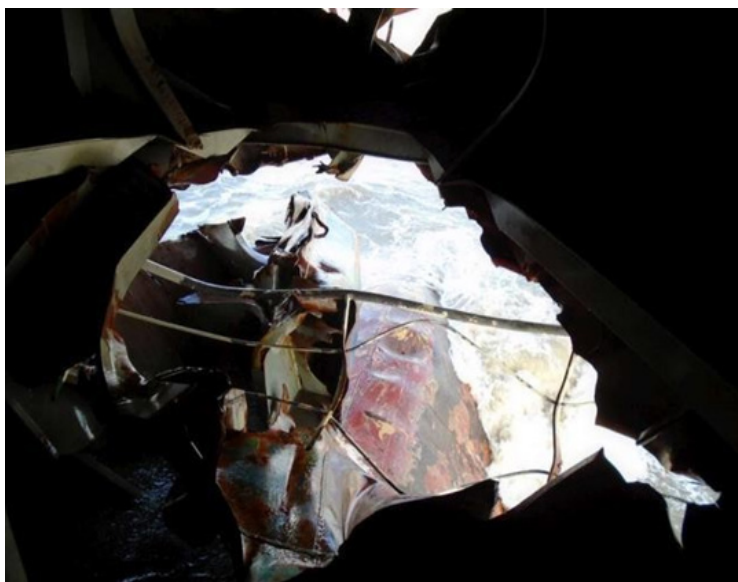
**Hull damage impairing seaworthiness**

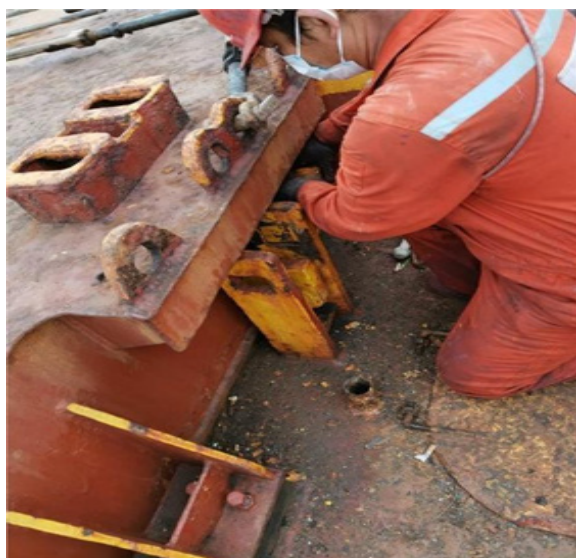
**Five cleats for No.4 and No.5 cargo hold hatch cover out of order**

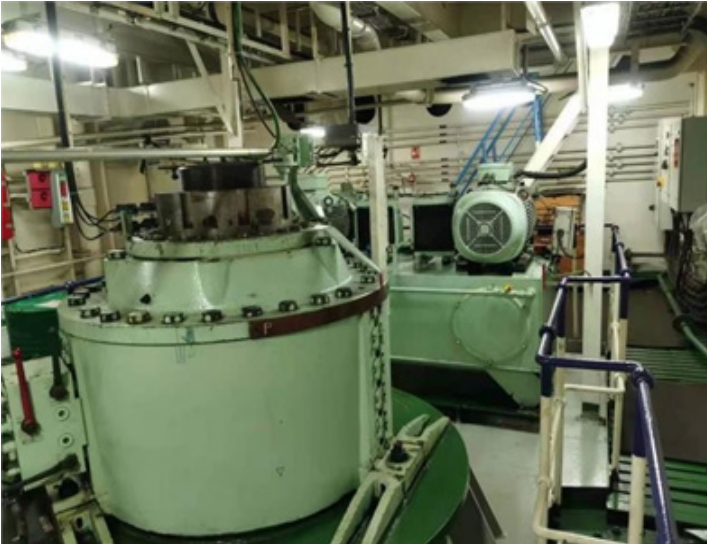
**The steering gear was unable to operate from bridge due to failure**

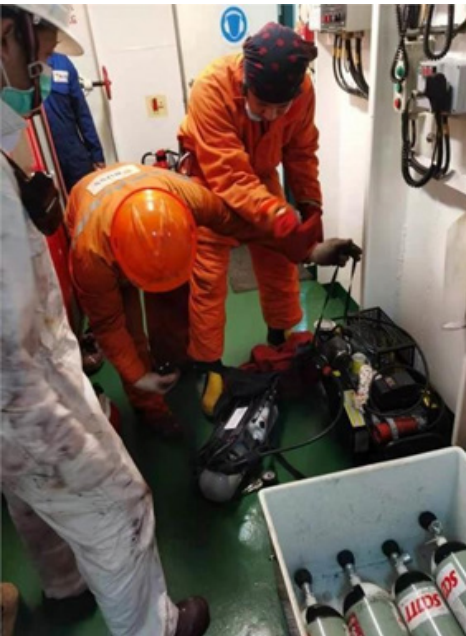
**The designated crew not familiar with the wearing of fireman outfit**

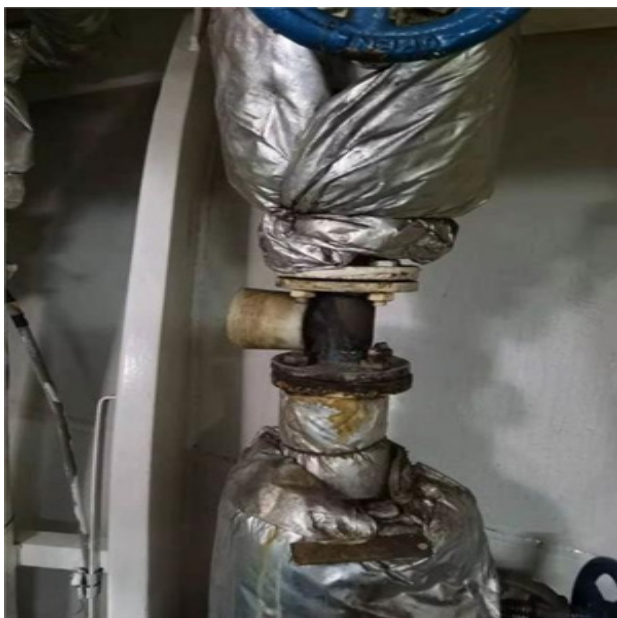
## Pipe for boiler feed water system temporarily repaired with nylon block

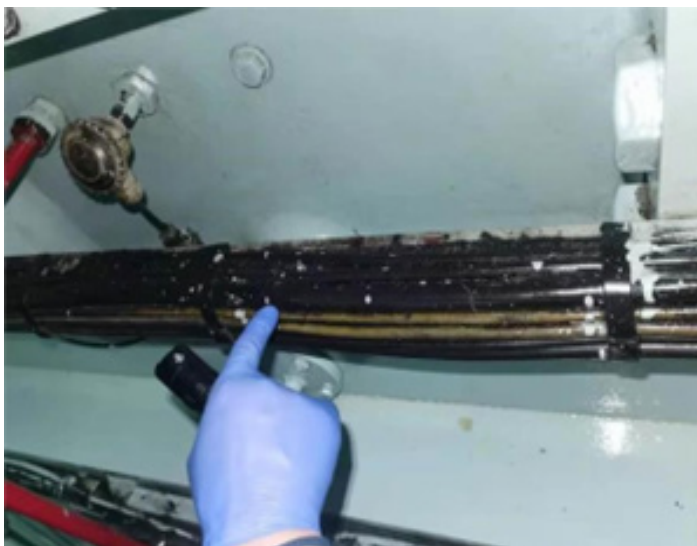
## Cables of main engine control unit nearby M/E scavenging box accumulated

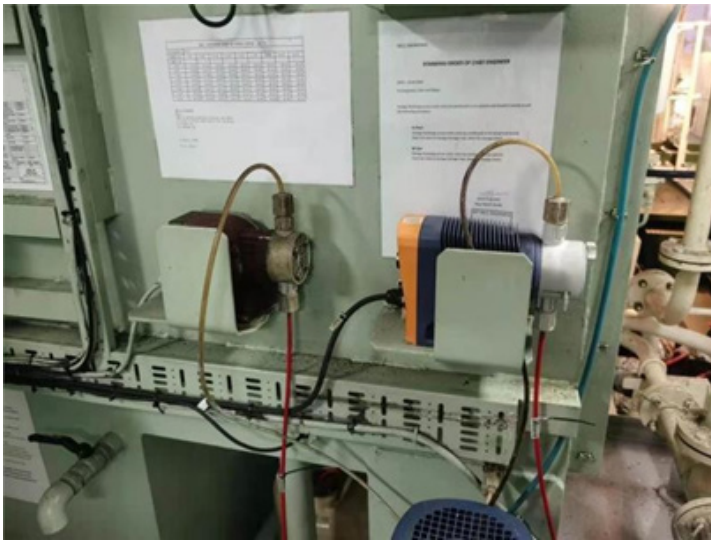
## The key engineers not familiar with the testing of the chemical pumps for

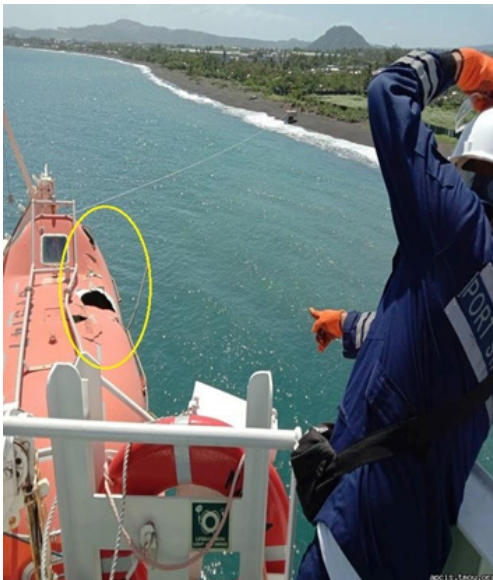
## Lifeboats: Portside Lifeboat Nr 2 Partly Broken

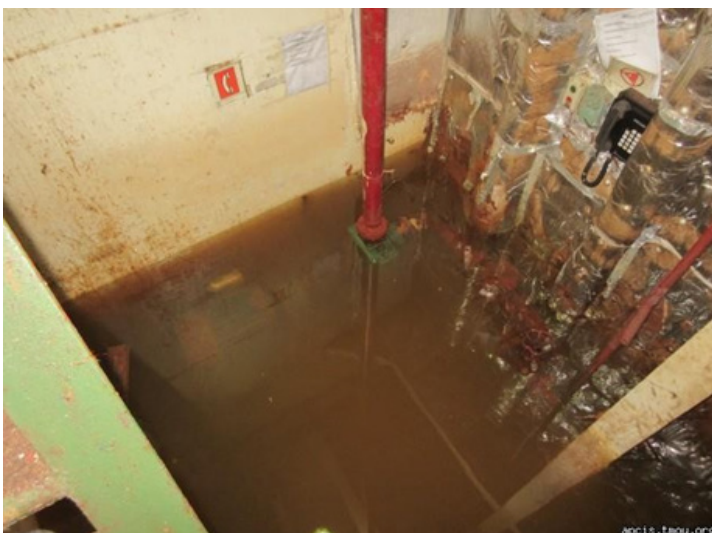
## Emergency fire pump and its pipes: Emergency fire pump - out of order

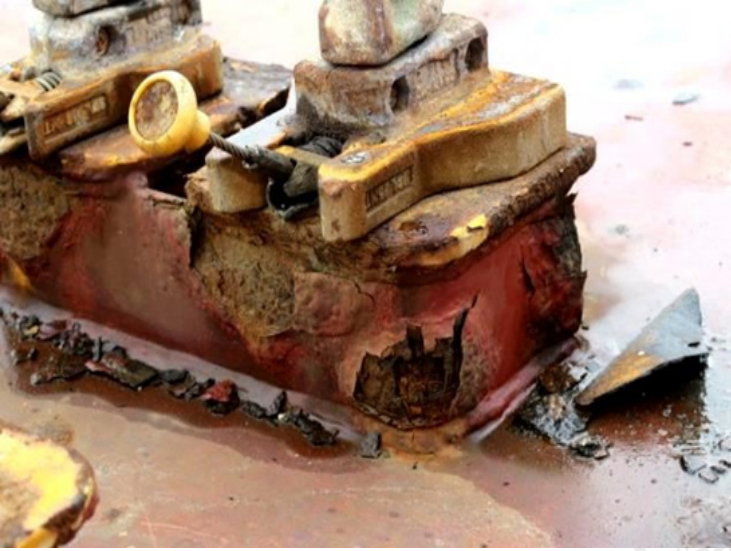
## Cargo operations including equipment: Lashing material - Lots of sockets

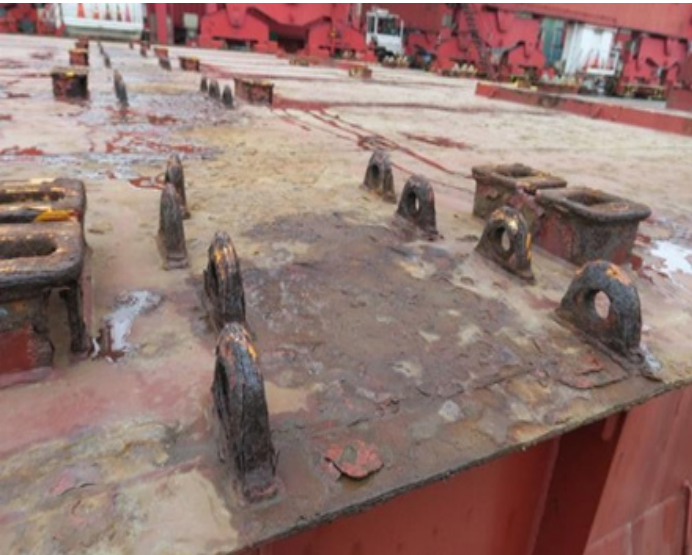
Sockets and lashing eyes in cargo area found corroded seriously.

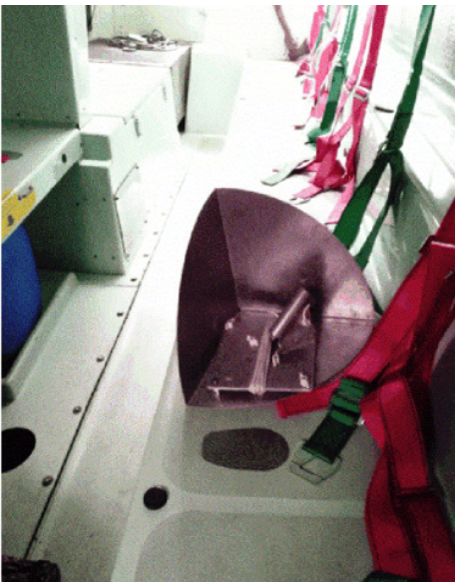
HOLDING ROD FOR RADAR REFLECTOR OF STARBOARD SIDE  
LIFEBOAT NOT AVAILABLE

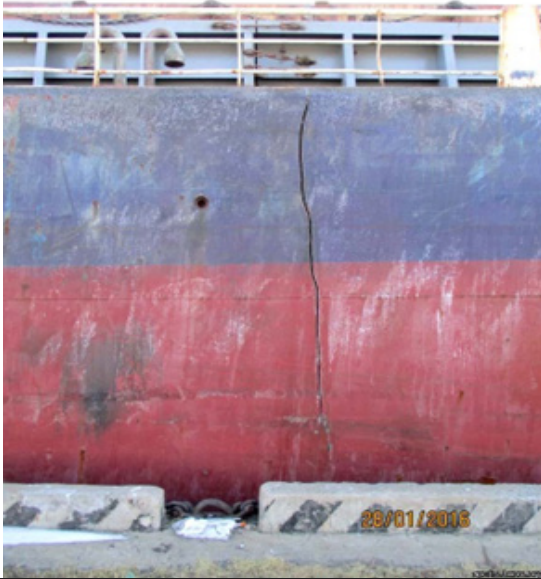
## Hull – cracking

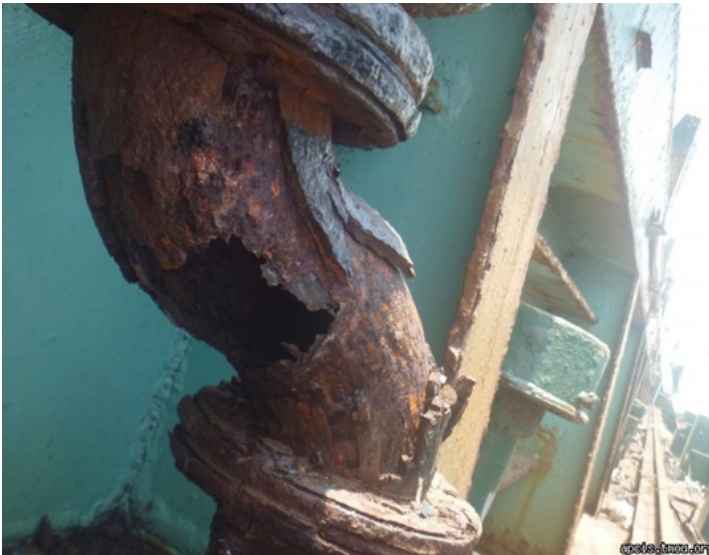
Starboard side fuel oil tank vent pipe corroded/ broken.

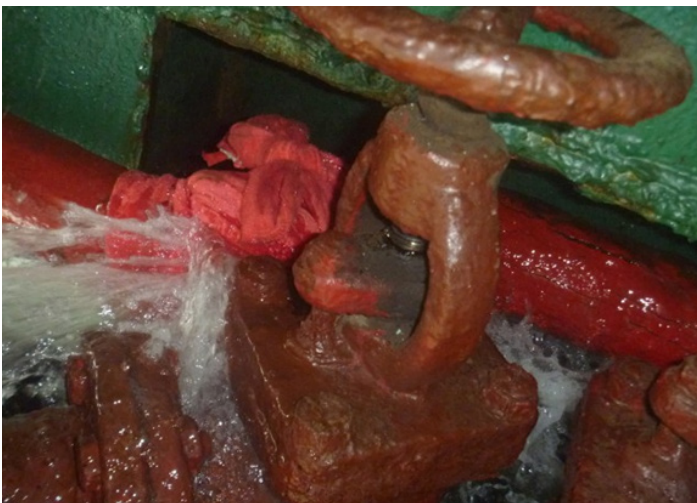
Fire main pipe in no.2 cargo hold leaking during testing

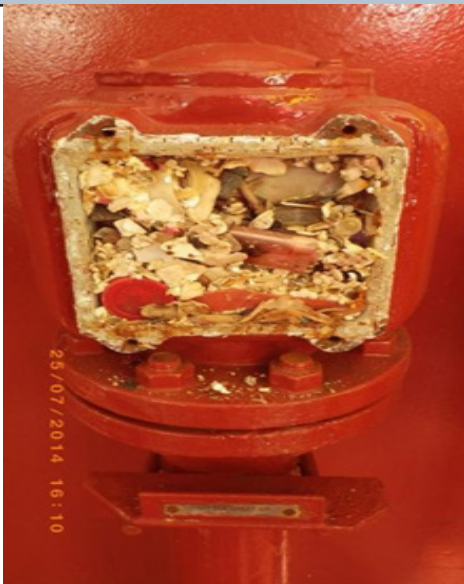
## Water/Weathertight condition: Ventilators, air pipes, casings-Both Port and

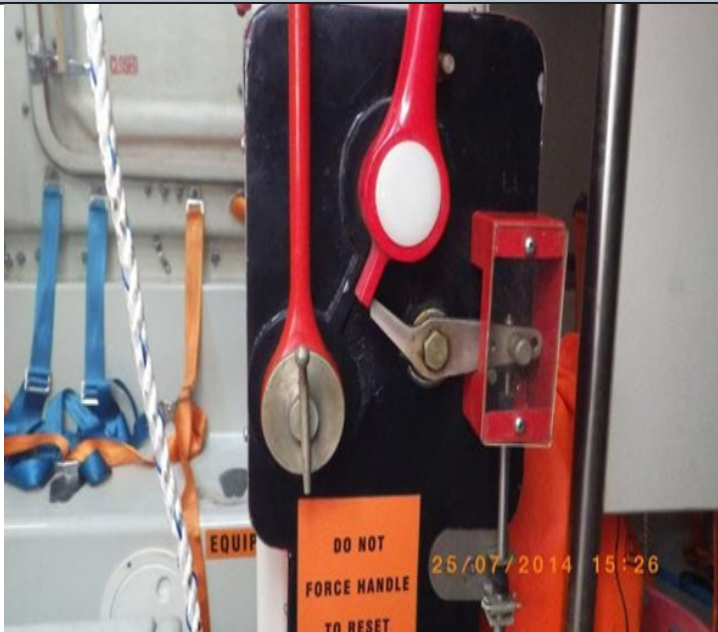
## Both port and starboard lifeboats release system: stop lever B not re-set

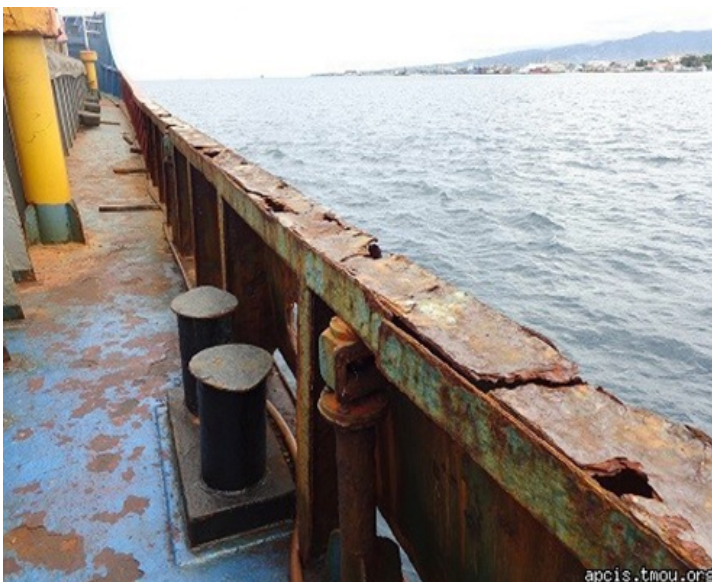
## Bulwarks and freeing ports-Deteriorated/Damaged

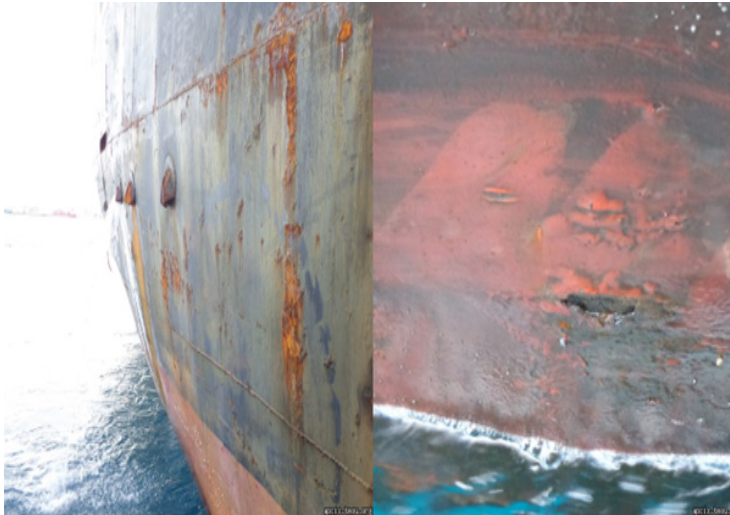
## DETERORATION DUE TO CORROSION LEADS A HOLE

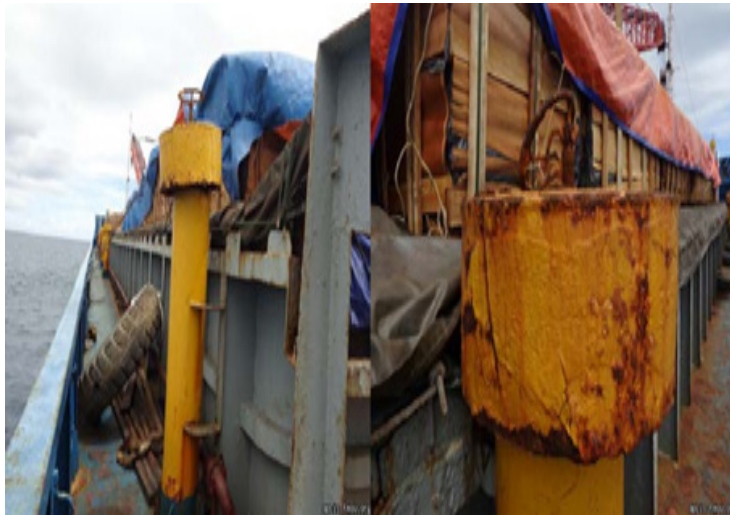
## DEFORMATION, DAMAGED/ CRACKING/CORROSION OF VENTILA-

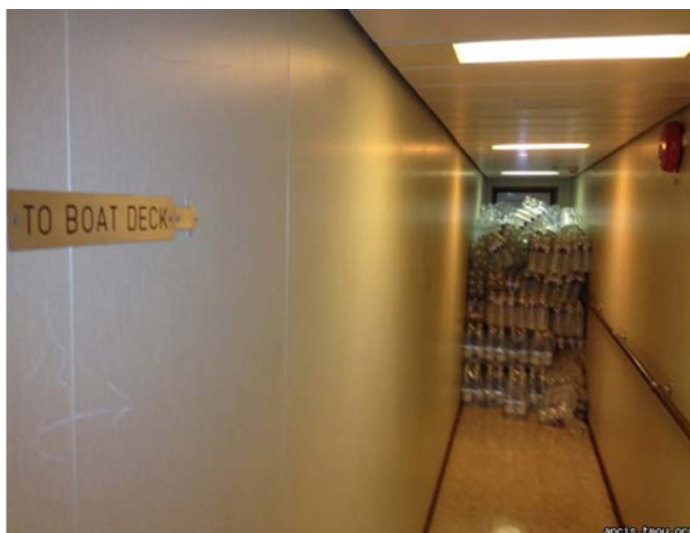
Exit to "E" deck (stern) & from "B" to boat deck partially blocked

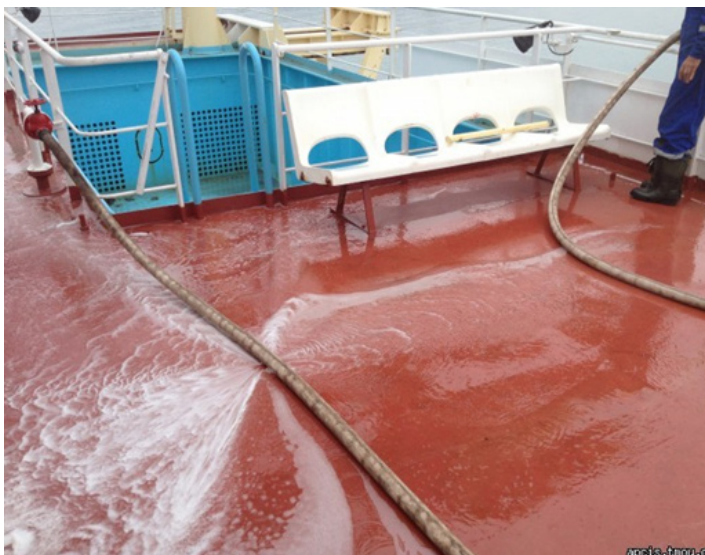
## BRIDGE DECK (STB) FIRE HOSE HOLED

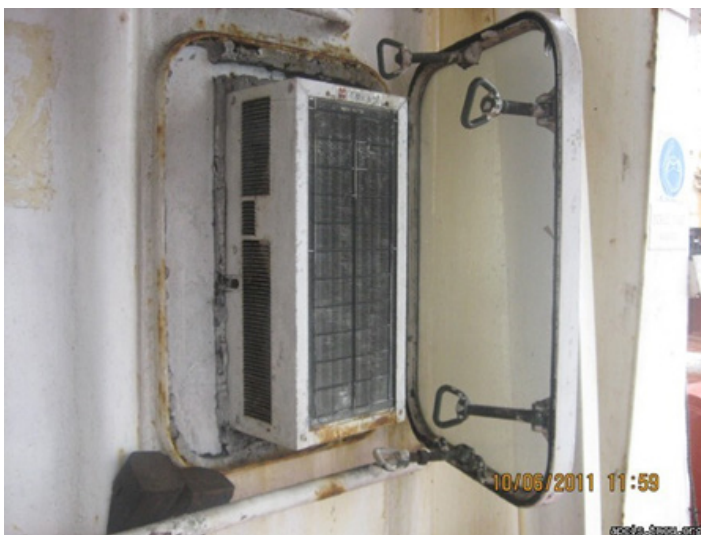
## Unauthorized air conditioners are fitted

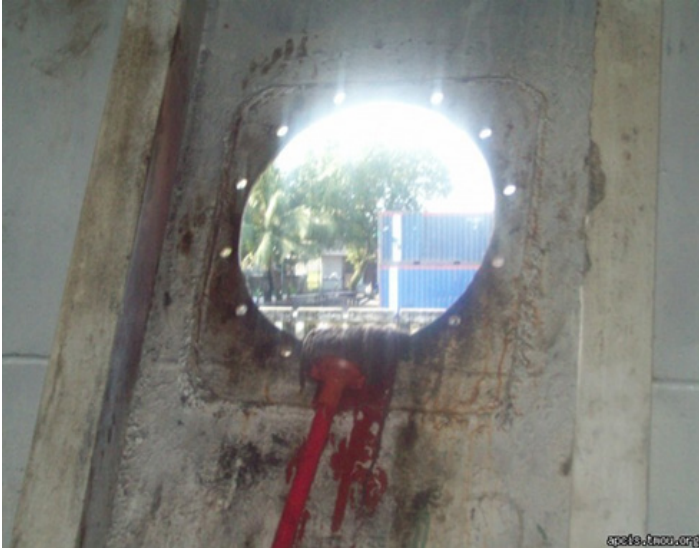
## Windows, sidescuttles and deadlights

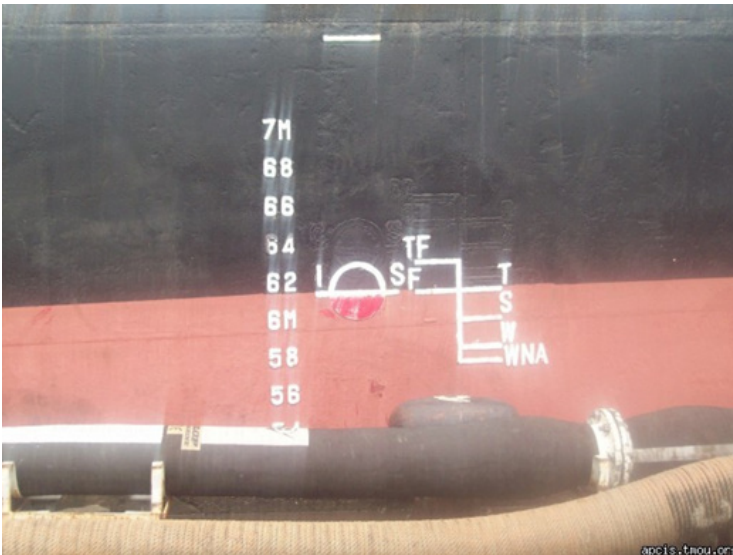
## LOADLINE MARKS AND LINES INCORRECTLY ASSIGNED

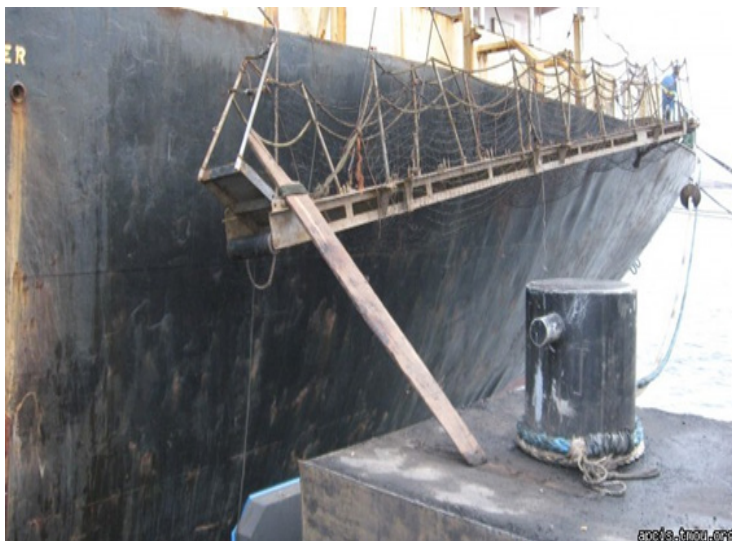
## Accident prevention- Accommodation ladder in poor condition

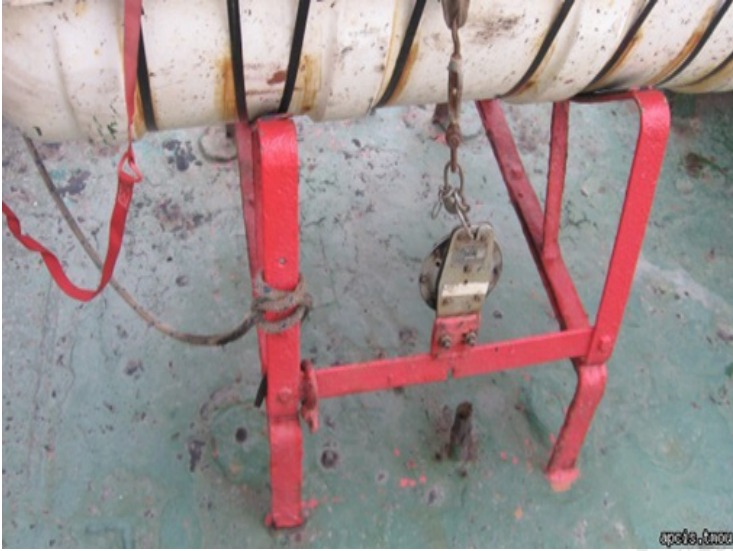
## STOWAGE OF LIFERAFT (P.S.) - WEAK LINK IS MISSING

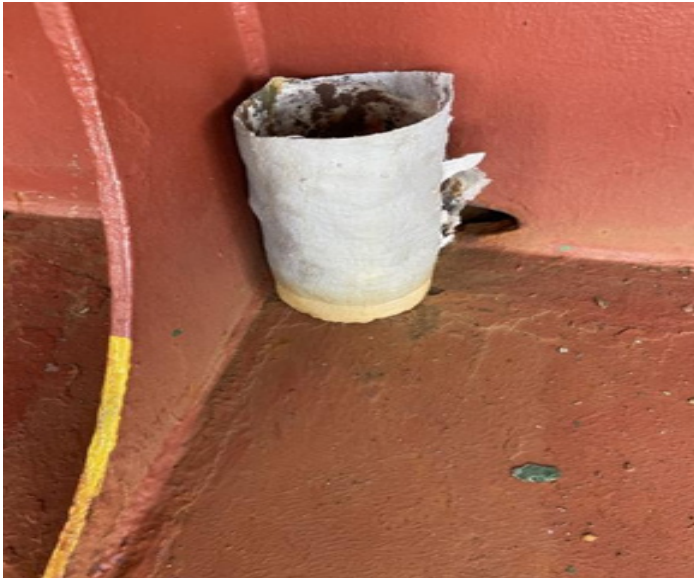
## CLOT H BANDAGES VENT PIPE

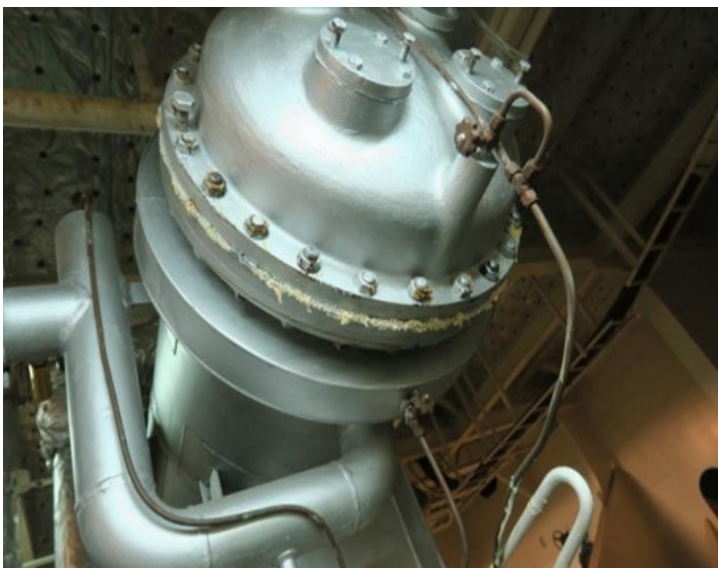
## GASKET OF SIDE COVER FOR THE AUX.CONDENSER FOUND SEA SALT
