**MARINER'S  
UPDATE**  
COMPLIANCE WITH SIMPLICITY

# ENTRY GUIDE CHINA

# 20 YEARS PSC OBSERVATIONS

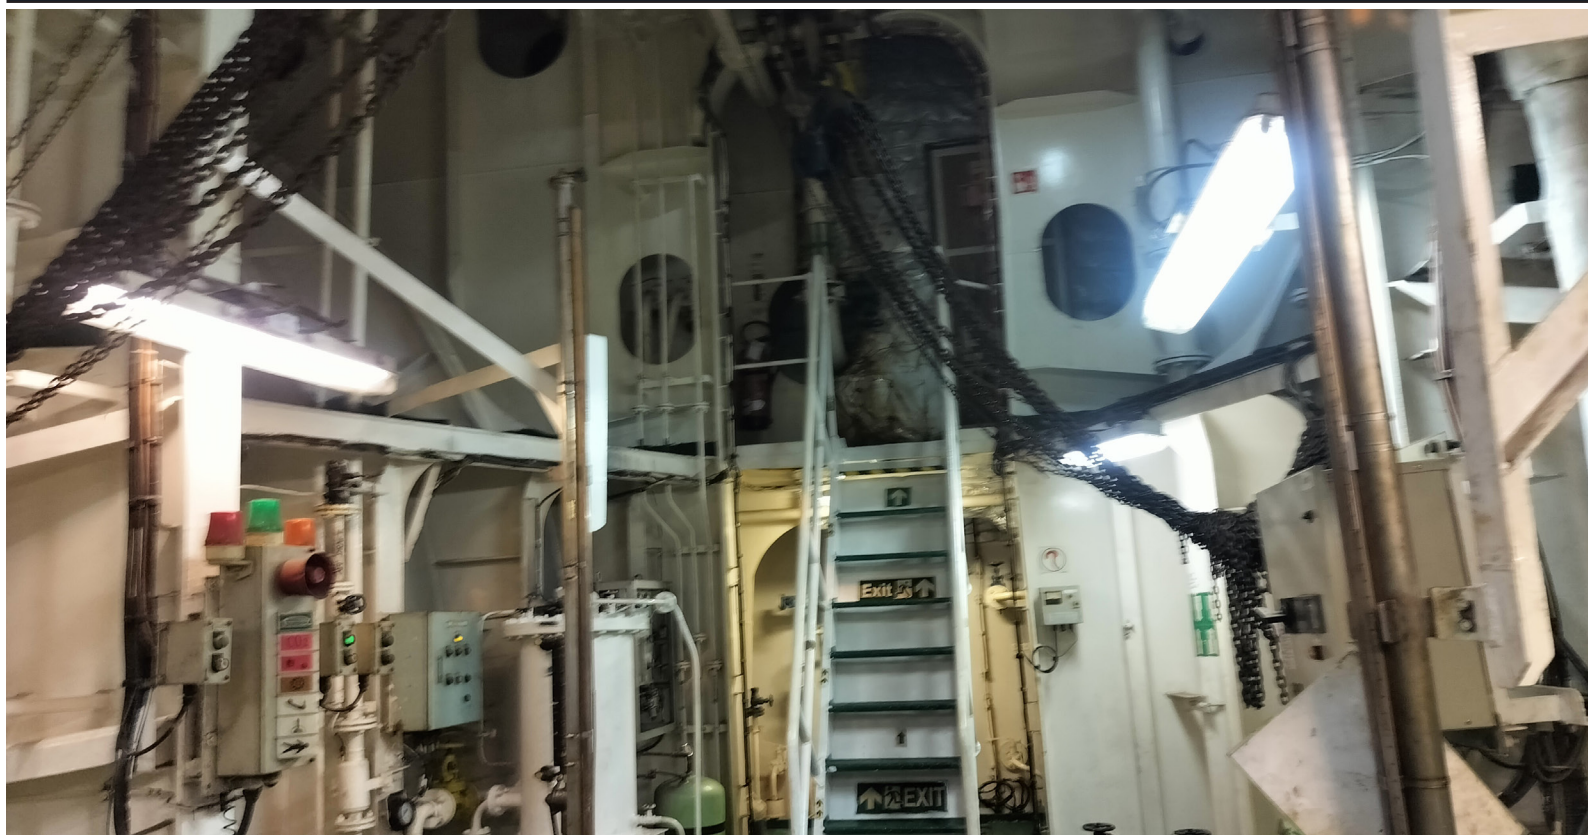
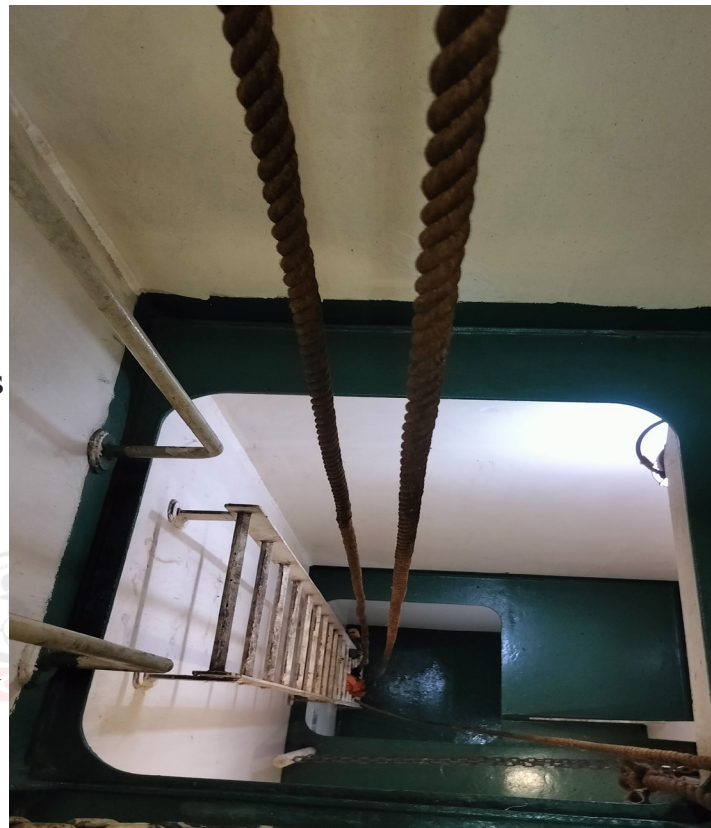
# E/RM ESCAPE ARRANGEMENT NOT EXTEND TO LOWER PLATFORM ?

One of the fire safety objectives of SOLAS chapter II-2 is to “provide adequate and readily accessible means of escape for passengers and crew”. As such, one of the options for compliance with SOLAS reg. II-2/13 for means of escape from machinery spaces is the fitting of a vertical escape trunk “from the lower part of the space”.

IACS UI SC277 (applicable to ships contracted from 1 February 2016) and MSC.1/Circ.1511 both include the following interpretation “the lower part of the space should be regarded as the lowest deck level, platform or passageway within the space”.

PSC inspections in Asia have been raising deficiencies against ships (built after IACS UI SC277 and MSC.1/Circ.1511 became effective) where the escape trunk does not proceed all the way to the lowest level of the engine room and which instead have short, inclined stairs leading from the bottom level of the engine room to the lowermost door of the engine room escape trunk.

For ships, where the engine room escape trunk does not lead to the lowest level of the engine room, the following measures are recommended:

- **D.** The technical justification should be kept onboard the ship, available to be presented to Port State Control or other parties when required.
- **E.** Operators should ensure they have adequate procedures in the SMS to cover rescue drills for evacuating injured persons from the engine room.

- **F.** In addition, the crew should familiarise themselves with the arrangement on board and practise and record rescue drills, as per the Company SMS requirements.
