**MARINER'S  
UPDATE**  
COMPLIANCE WITH SIMPLICITY

# ENTRY GUIDE CHINA

# 20 YEARS PSC OBSERVATIONS

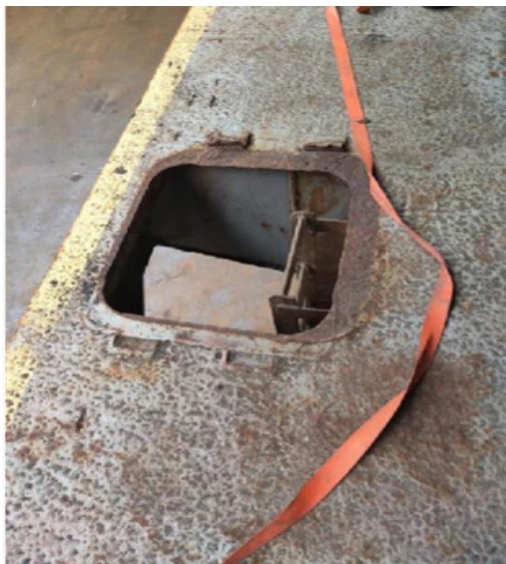
**One manhole cover in the safety passage on the second deck of NO.1 hold**

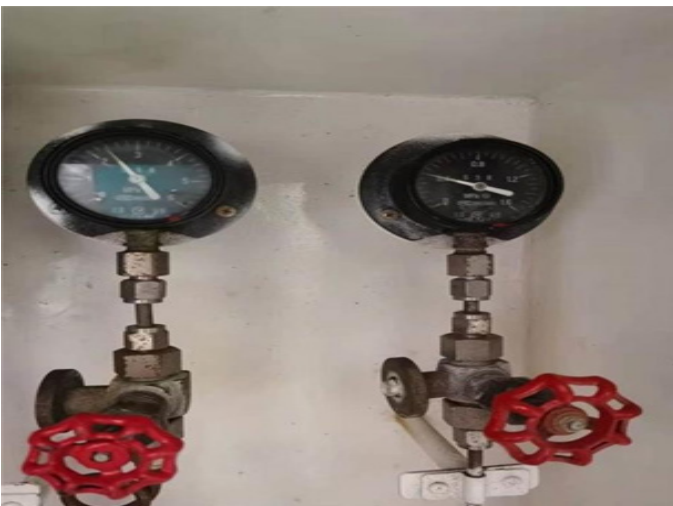
**The air pressure of the air cylinder for oil tank quick-closing valves low**

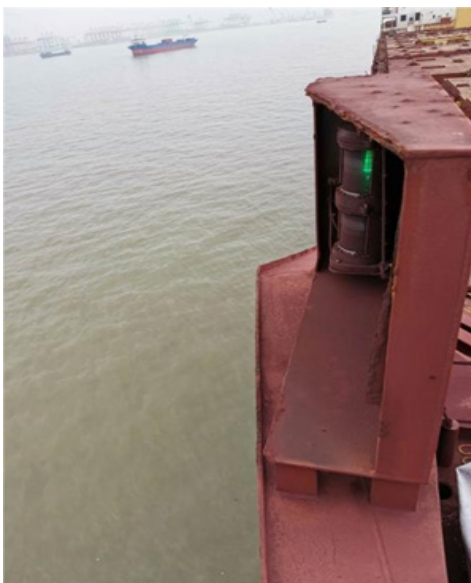
## The lower light of starboard side light unlit

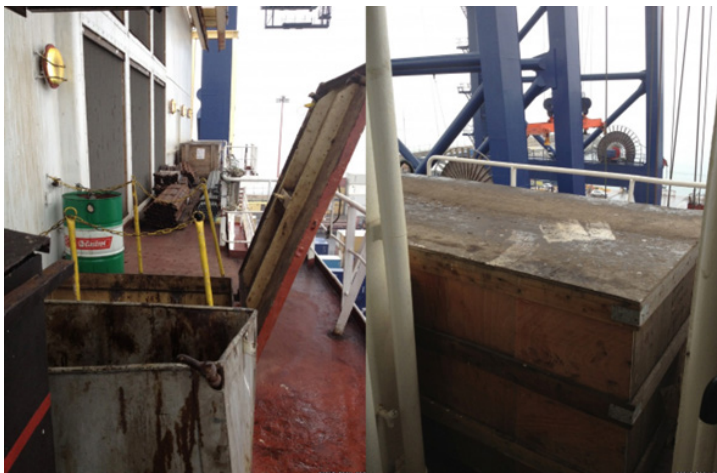
## FROM "B" TO BOAT DECK PARTIALLY BLOCKED
